NIST NCSTAR 1-5A

Federal Building and Fire Safety Investigation of the World Trade Center Disaster

Visual Evidence, Damage Estimates, And Timeline Analysis

(Chapter 9 - Appendix C)

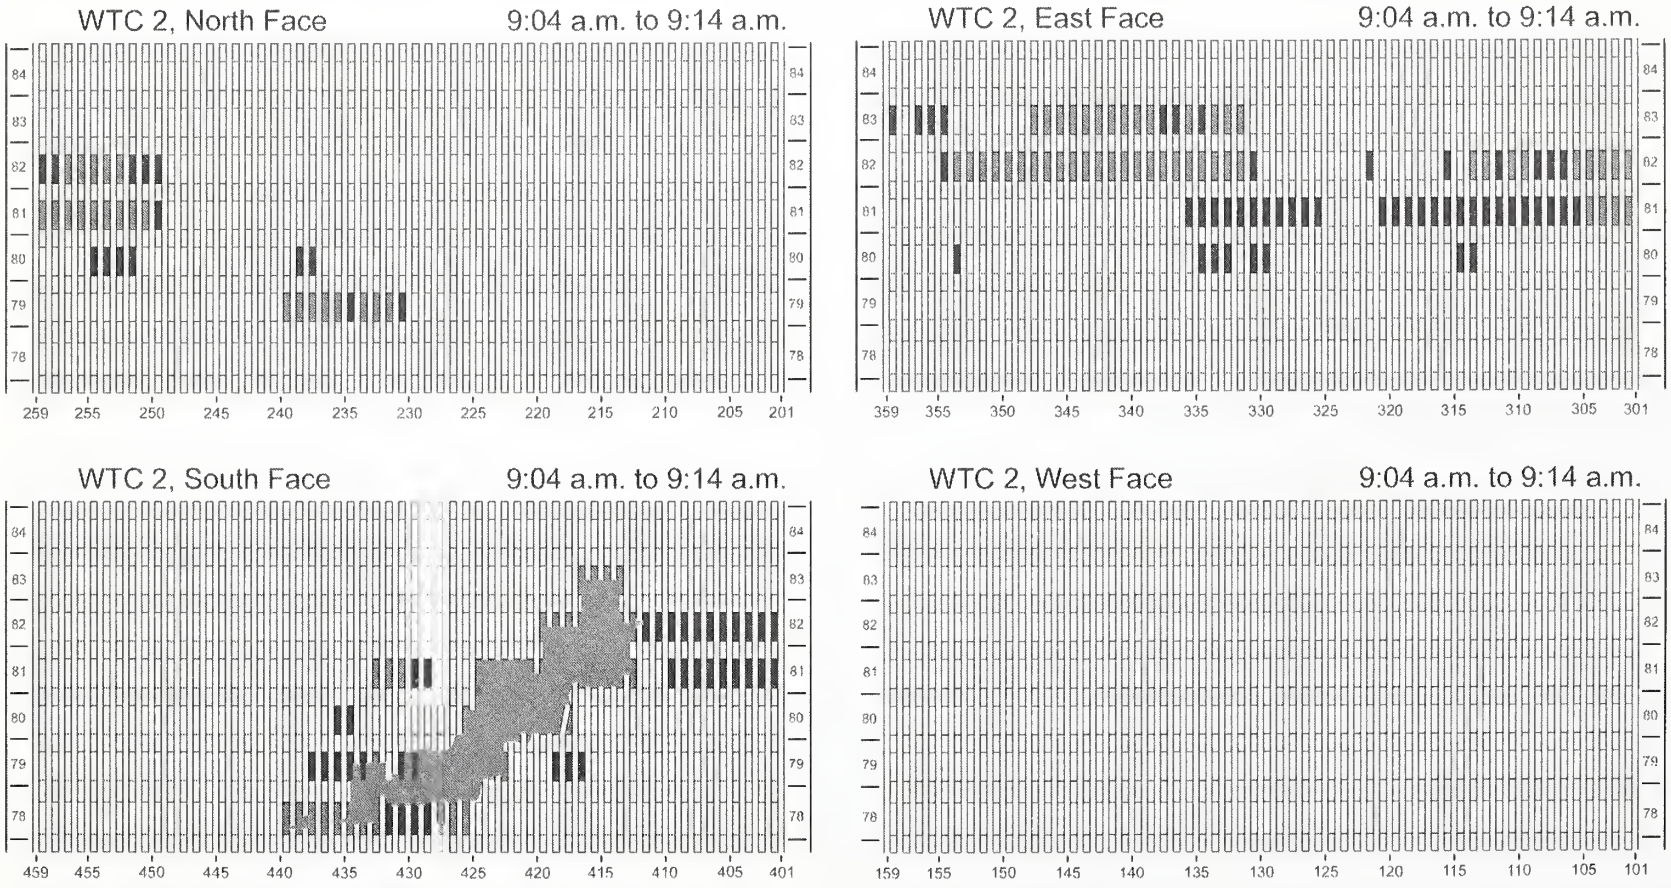
On the north face large fires were initially ignited on the eastern edges of the 81st and 82nd floors and at a location more toward the center on the 79th floor. On the 79th and 81st floors these fire were burning on large piles of debris located just inside the façade. These fires continued to burn intensely during the entire period. There was little indication of fire spread or additional growth. Little smoke and flame were observed in an area of the façade, covering the 80th, 81st, and 82nd floors and extending from column 238 to column 250, lying between the fires on the 81st and 82nd floors and the fire on the 79th floor. This area is referred to as the cold spot.

Immediately following the aircraft impact, extensive fires were visible on the east face over the northern halves of the 81st and 82nd floors and on the southern portion of the 83rd floor. An intense fire was also burning within the debris-filled opening created in the northeast corners of the 81st and 82nd floors by the aircraft impact. Smaller isolated fires were present on the 80th floor. The fire on the southern side of the 83rd floor died down rapidly, while a large fire appeared and rapidly grew on this side of the 82nd floor. The fires on the northern ends of the 81st and 82nd floors and in the northeast corner continued to burn vigorously during the entire period. Only small fires were visible on lower floors.

Figure 9-19. Maps of integrated fire observations between 9:04 a.m. and 9:14 a.m. are shown for the four faces of WTC 2. Colors represent the highest intensity fire observed in a window using the color scale defined in Figure 5-1.

Several small fires were visible on the south face shortly following the aircraft impact. These fires were located within the aircraft impact cavity and immediate adjacent areas. During the period considered here, these fires spread and grew relatively slowly. The only visible area of extensive fire spread was on the eastern side of the 81st floor, where a large fire grew between 9:07 a.m. and 9:11 a.m., and immediately above on the 82nd floor, where a fire was observed just prior to 9:15 a.m., after the fire on the 81st floor had died down.

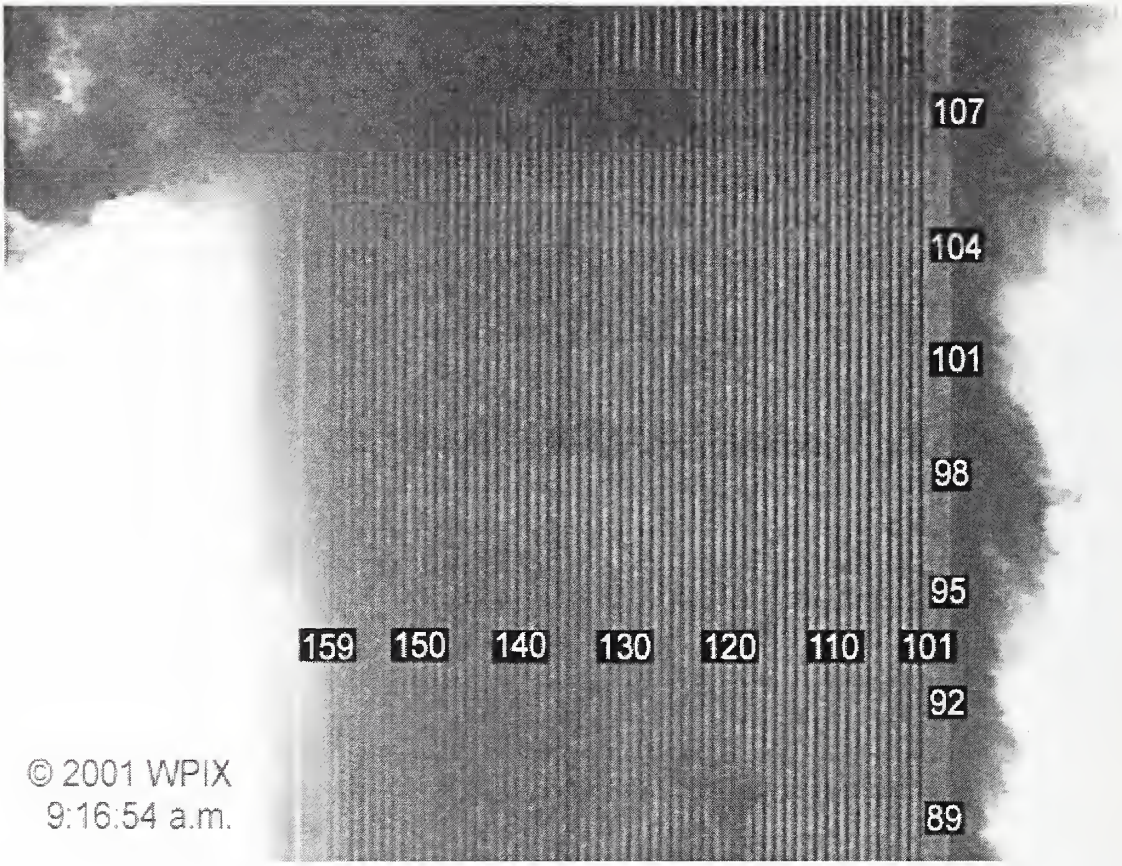
Figure 9-20. This image of the west face of WTC 2 was captured from a video shot from a news helicopter at 9:16:54 a.m. It has been enhanced by adjusting the intensity levels, and bright areas to the right and left of the tower are saturated. Column and floor numbers have been added.

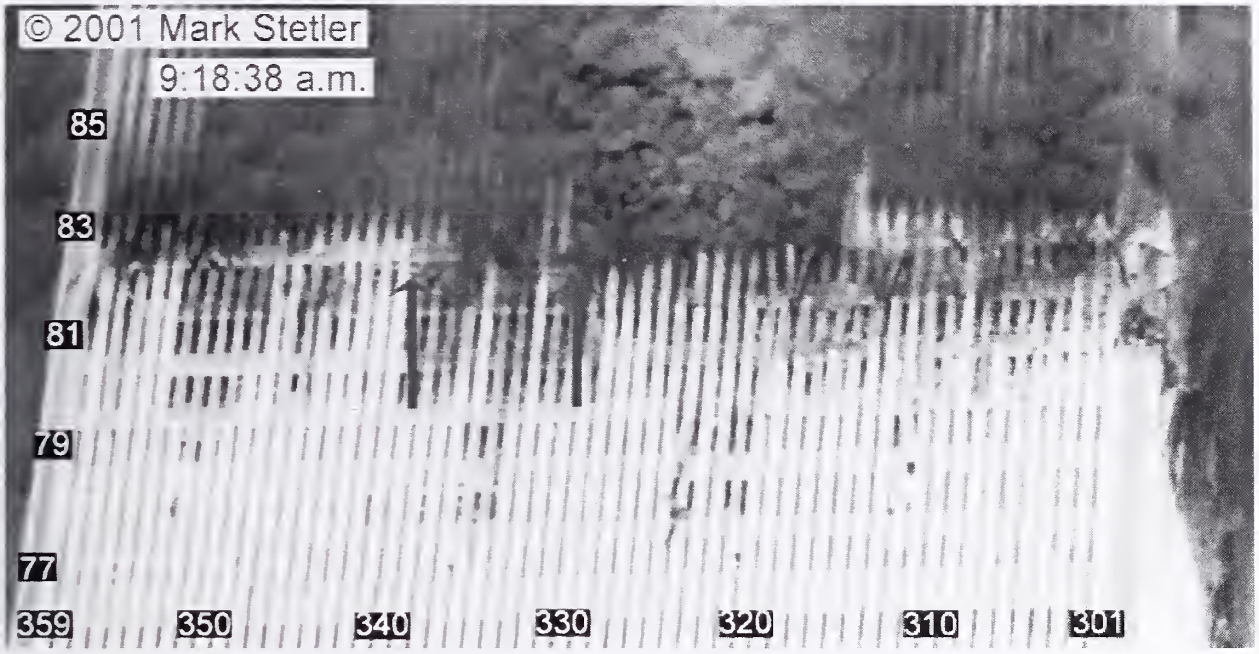
A photograph of the east face of WTC 2 at 9:18:38 a.m. is shown in Figure 9–21. It was taken almost 6½ min after the photograph reproduced in Figure 9–14 and Figure 9–15. Comparison with the earlier images indicates that the fire burning on the southern side of the 82nd floor has subsided during the intervening time. At the earlier time, intense flames completely filled windows 82-333 to 82-342 and hid the hanging object that had been visible in this area shortly after the aircraft impact. As indicated by the arrows added to Figure 9–21, the object was once again visible at 9:18:38 a.m. A review of photographs and videos recorded during the intervening period indicated that the view of this area had gradually

The fires on the northern edges of the 81st and 82nd floors and in the opening on the northeast corner continue to burn intensely at a level comparable to that seen at 9:12:11 a.m. in Figure 9–14. There is still very little indication of a fire near the southern edge of the 81st floor. A small fire remains on the 80th floor near window 80-335. Heavy flows of smoke continue from the southern side of the 83rd floor and from near the center of the 82nd floor.

In the photograph taken at 9:18:38 a.m. there is no indication of significant smoke flow on the east face from windows lower than the 82nd floor. This was generally true around this time, but was not always the case. Starting around 9:12:45 a.m. a series of short-lived, apparently coordinated smoke releases were observed in which smoke was pushed out of multiple open windows on the 79th, 80th, and 81st floors.

Figure 9-21. View of the east face of WTC 2 recorded at 9:18:38 a.m. The original photograph has been cropped and enhanced by adjusting intensity levels. Column and floor numbers have been added. The arrows highlight a hanging object observed through open windows on the 82nd floor.

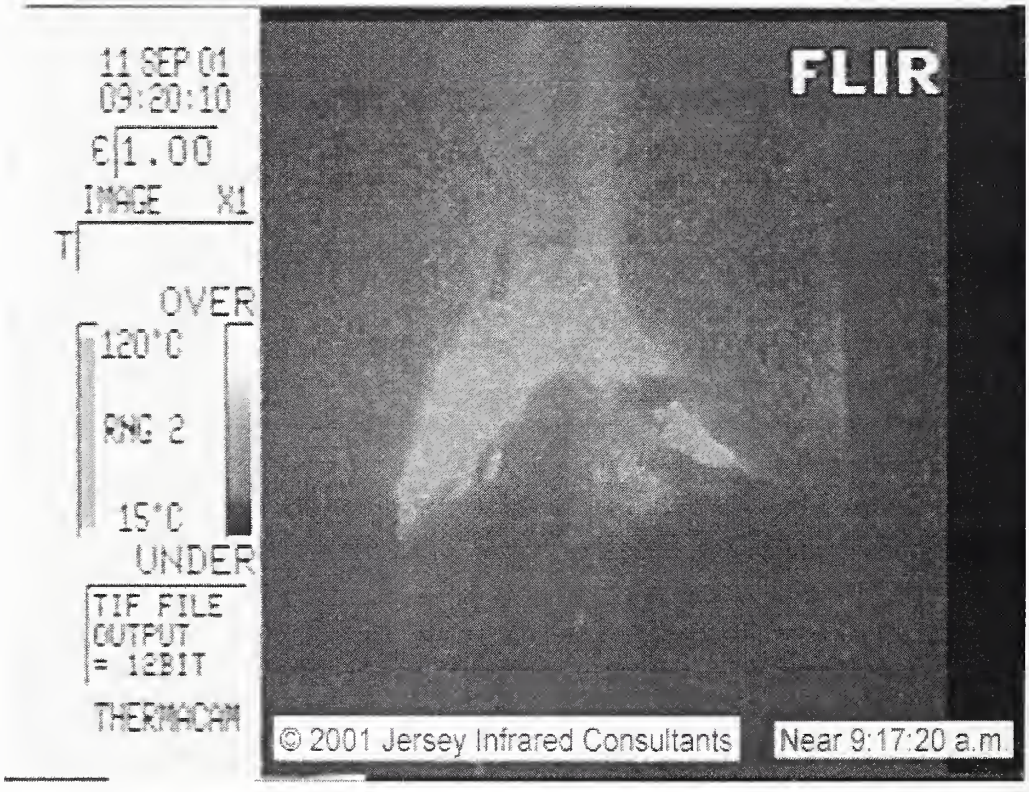
Figure 9-23. This image shows a frame from the false-color output of an infrared camera that was connected to a standard video camera. The time was around 9:17:20 a.m. (an uncertainty of 15 s is assigned). Blue represents the coolest temperatures and red the warmest temperatures.

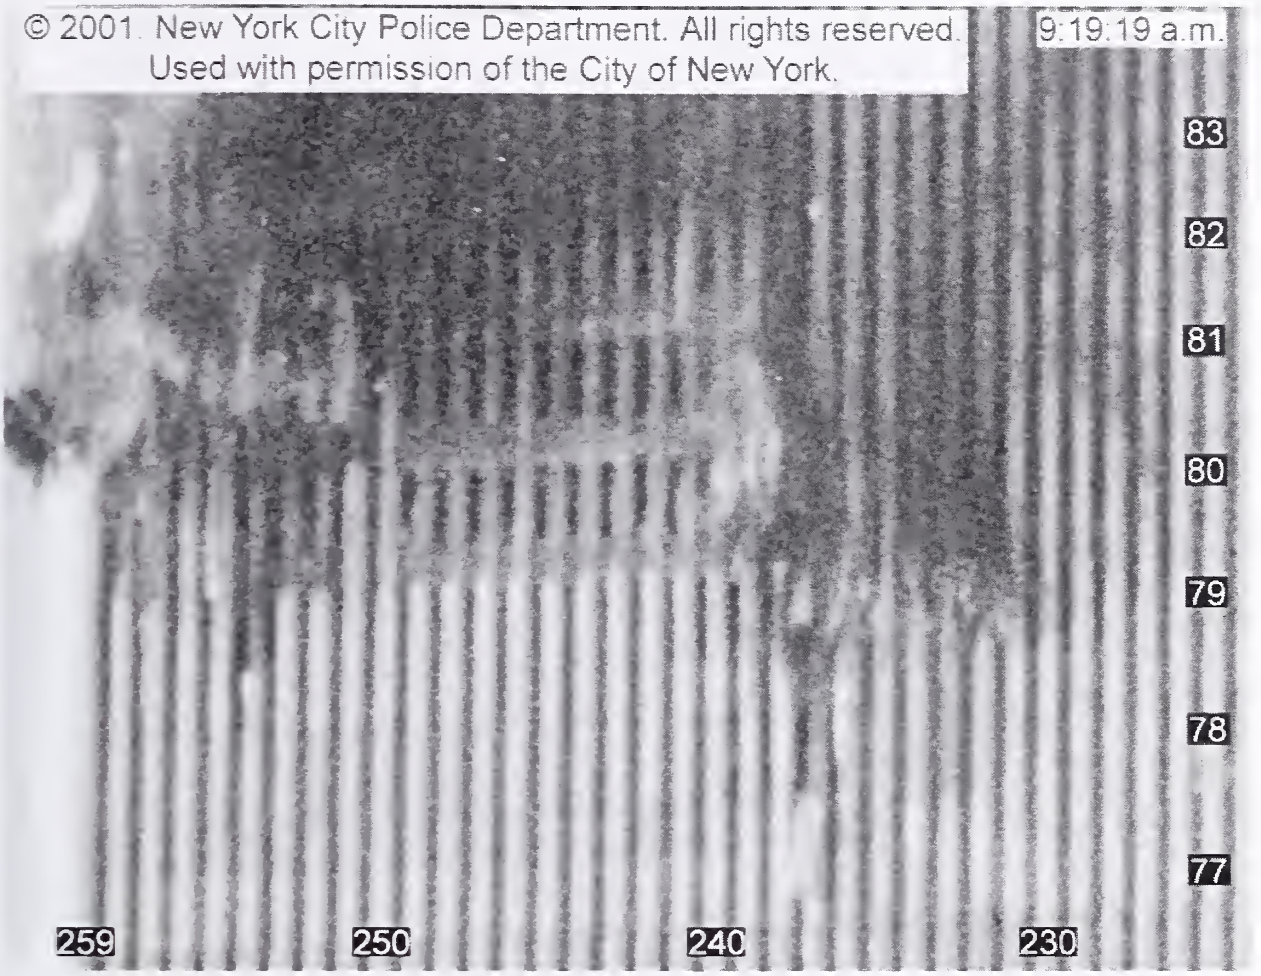
Figure 9-24. This cropped photograph shows the north face of WTC 2 at 9:19:19 a.m. The image has been enhanced by adjusting the intensity levels, and column and floor numbers have been added.

A view of the north face recorded at 9:27:04 a.m. is shown Figure 9–32. It was shot nearly 8 min after the image shown in Figure 9–24. The fire distribution on this face has changed very little during this period. The intense fires ignited immediately following the aircraft impact on the east edges of the 81st and 82nd floors continue to burn, even though the fire intensity on the 82nd floor has continued to decrease. The fire in the northeast corner opening on the 81st floor also decreased in size. The column in the corner of the 82nd floor, column 82-300, which was hidden by flames in Figure 9–24, is now fully visible.

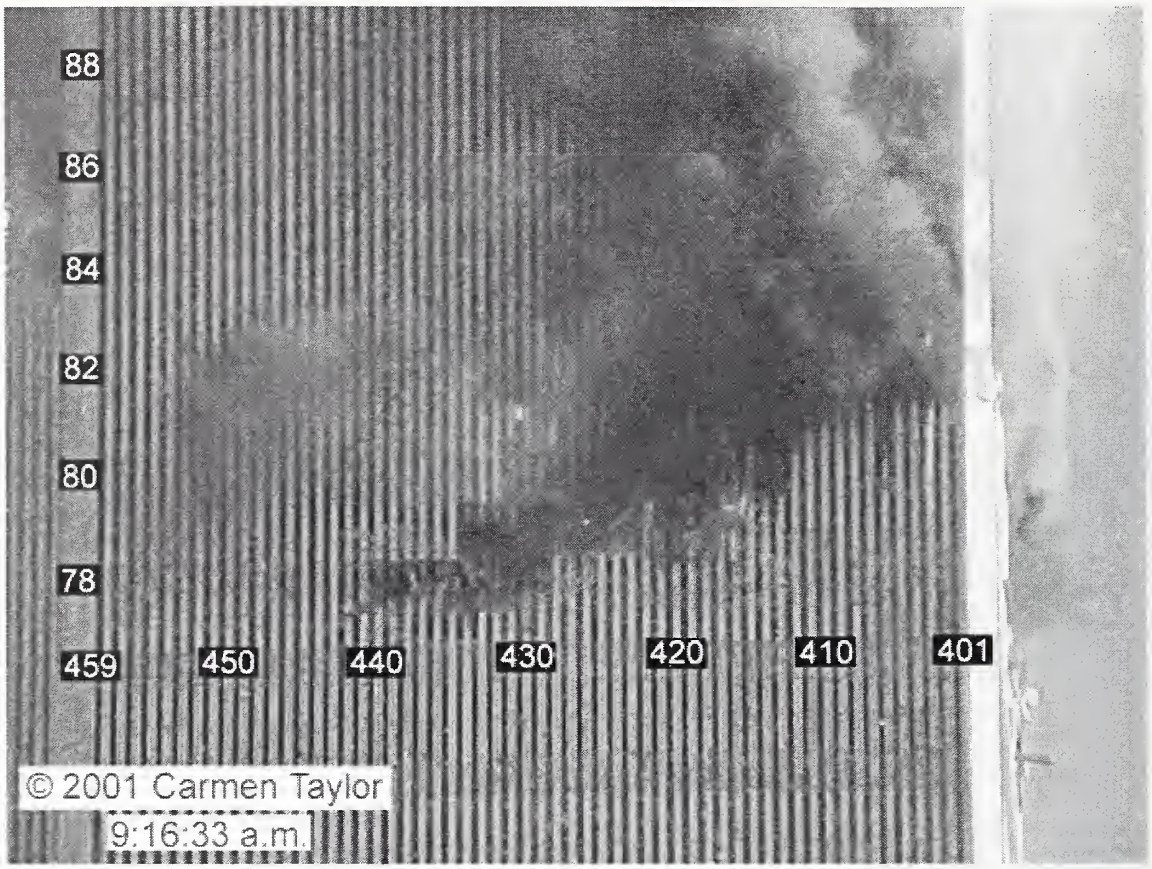
A later view of the south face taken at 9:23:08 a.m. is shown in Figure 9–26. During the nearly seven minutes since Figure 9–25 was shot, the fire that had appeared on the east side of the aircraft impact cavity on the 79th floor has grown and spread toward the east. The most intense flames are now observed in windows 79-413 to 79-415, and heavy smoke is coming from windows 79-411 and 79-412. At the earlier time flames were coming out of windows 79-415 to 79-417, and heavy smoke was coming from windows 79-412 to 79-414. A heavy smoke flow is also coming from window 79-406 at the later time.

The fires on the east sides of the 81st and 82nd floors have similar appearances in the two photographs. The same is true for the lower intensity fire burning on the 78th floor just to the east of aircraft impact cavity. The small fire to the west of the aircraft impact cavity on this floor is still, just barely, visible. The fire higher up on the 81st floor has grown brighter and now extends over windows 81-429 to 81-433. Comparison with Figure 9–10 and Figure 9–18, which were shot at 9:06:31 a.m. and 9:11:17 a.m., respectively, indicates that this fire has not spread significantly, but that its intensity seems to fluctuate with time.

Figure 9-25. This photograph shows the south face of WTC 2 at 9:16:33 a.m. The south face of WTC 1 is visible to the left of the western edge of WTC 2. Column and floor numbers have been added.

Figure 9-26. This cropped photograph shows the south face of WTC 2 at 9:23:08 a.m. The image has been rotated and enhanced by adjusting the intensity levels. Column and floor numbers have been added.

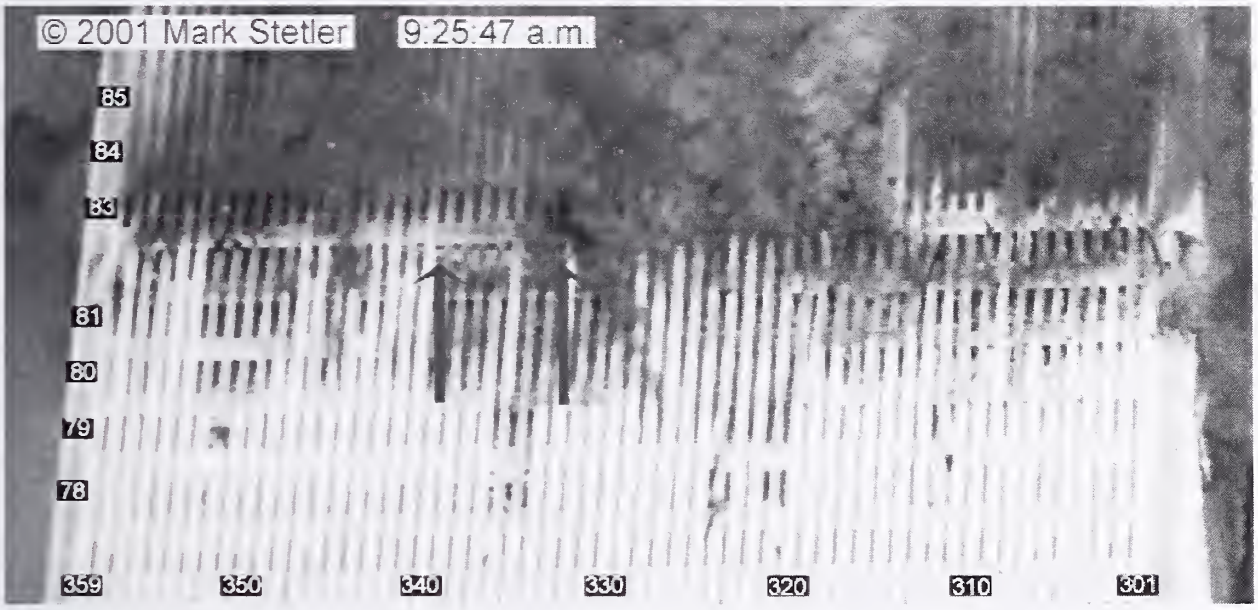
A photograph of the east face of WTC 2 at 9:25:47 a.m. is shown in Figure 9–27. This image was taken 7 min and 9 s later than the similar photograph reproduced in Figure 9–21. Arrows added to the figure indicate the hanging object observed earlier through windows on the 82nd floor. Its appearance has changed substantially from earlier times (compare with Figure 9–1, Figure 9–2, and Figure 9–21). In the vicinity of window 82-336, it is now visible lower down in the open windows. The hanging object no longer has the appearance of a thin line, but now looks like a curved sheet since the top of the object has been revealed. On either side of the dip the object remains high in the windows and still has the appearance of a line.

Figure 9-27. View of the east face of WTC 2 recorded at 9:25:47 a.m. The original photograph has been cropped and enhanced by adjusting intensity levels. Column and floor numbers have been added. The arrows highlight a hanging object (floor slab) observed through open windows on the 82nd floor.

By comparing Figure 9–6, Figure 9–14, and Figure 9–21 with Figure 9–27, it is apparent that the fire that grew on the south side of the east face on the 82nd floor shortly after the aircraft impact has continued spreading to the north. Intense flames are now coming from windows 82-321 to 82-329, while the fires have died down in windows further to the south. Heavy smoke is coming from windows as far north as window 82-316.

The fire distributions also changed at other locations on the east face between the times when Figure 9–21 and Figure 9–27 were taken. At the earlier time there was a large fire visible on the 82nd floor in windows 82-305 to 82-312 on the north side. By 9:25:47 a.m. this fire appears to have died down, and flames are no longer evident in this area. A flaming region is now present immediately above on the 83rd floor. Flames are visible on this floor in windows 83-302 to 83-312. In the earlier photograph heavy smoke was coming from these windows, but flames were not as evident. The fire burning in the northeast corner of the 81st floor appears to have decreased somewhat in intensity during the period. The heaviest flames are now coming primarily from the opening on the northeast corner of this floor. Even in this area, the flame lengths have decreased somewhat. It is now possible to barely discern the corner column 82-300, which is still in place, through the opening on the 82nd floor.

In Figure 9–27, the heaviest smoke is coming from windows on the 82nd and 83rd floors, and the lower floors are visible. A smoke plume is flowing from one of the windows, 79-227, on the 79th floor where there appears to be some flame visible, and light smoke can be seen exiting from a few other windows on the lower floors. Nevertheless, the general impression is that of little smoke flowing from floors lower than the 82nd. As mentioned above, this conclusion is somewhat misleading since brief periods of smoke release from lower floors had been observed starting before 9:13 a.m. Review of videos and photographs showed that these smoke releases increased in both frequency and the amount of smoke released as time progressed.

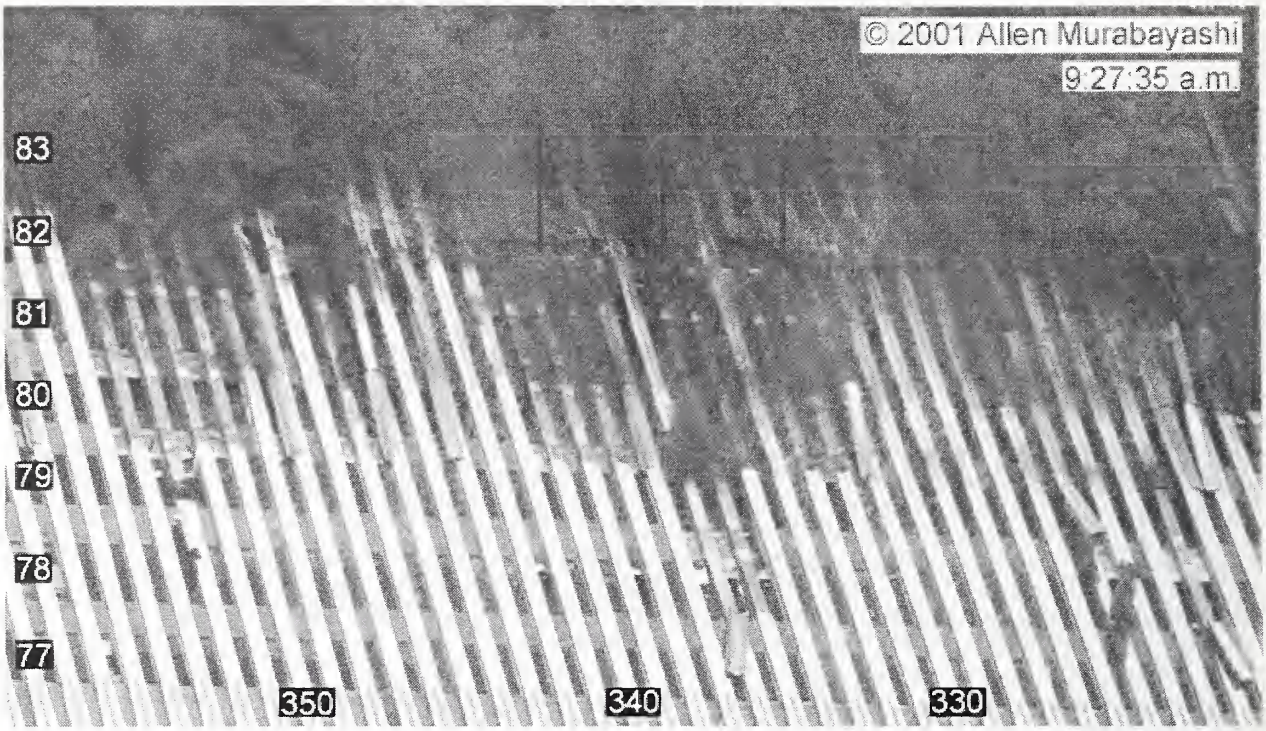
Another view of this object, shot from a different angle, is shown in Figure 9–28. This photograph was taken from a location on a nearby street to the southeast of the tower. As a result, the photograph is looking up at the hanging object from below. The arrows indicate the object. An enlarged view of the area with the object is shown in Figure 9–29. From this angle the object also has a sheet-like appearance, but, unlike in Figure 9–27, the underside of the object is in view. This is most easily seen in window 82-332. The sheet-like structure of the object is that which would be expected if the hanging object were a portion of the 83rd floor slab that, after having been dislodged from the east perimeter wall, had settled down further below the open windows on the 82nd floor. This closer view shows that the object was visible as far south as window 82-342 at this time. At earlier times the object was visible further to the north than in Figure 9–27, but these windows remain hidden by dark smoke.

Figure 9-28. This cropped photograph shows the east face of WTC 2 at 9:27:35 a.m. The original image has been rotated, and column and floor numbers have been added. The arrows highlight a hanging object observed through open windows on the 82nd floor.

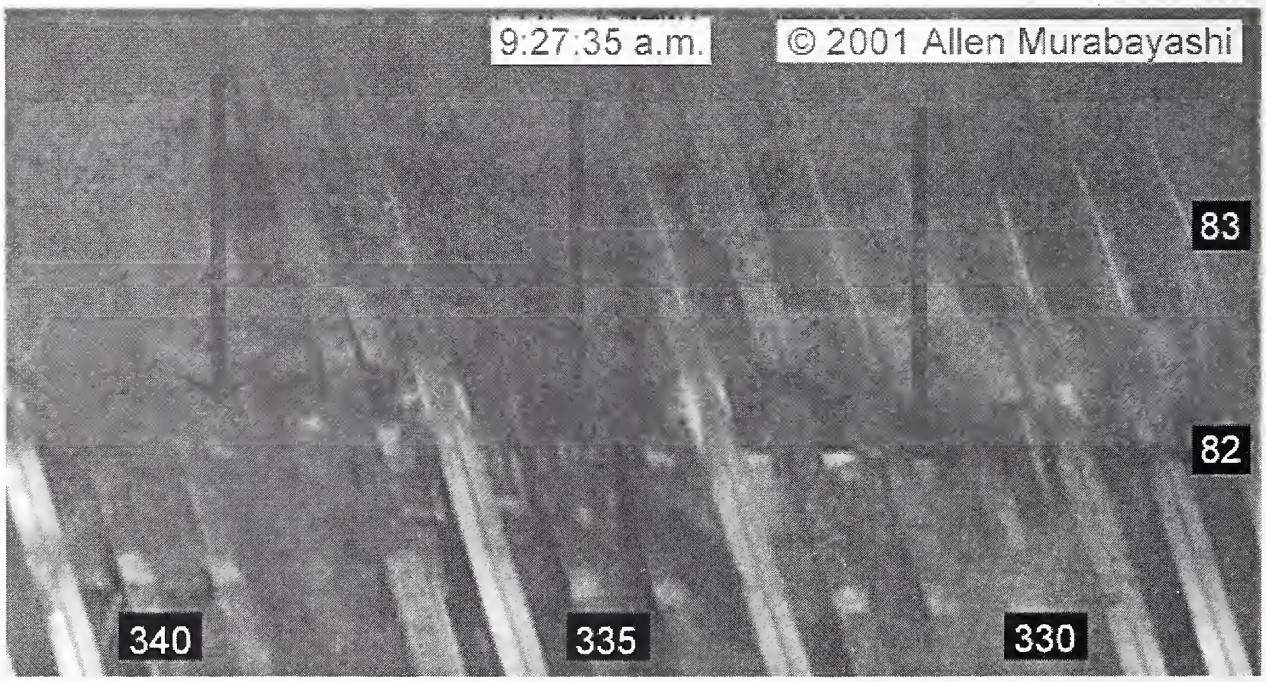
Figure 9-29. This image is an enlargement of a portion of Figure 9–28 showing the east face of WTC 2, where a hanging object is visible through open windows on the 82nd floor. Column numbers have been added.

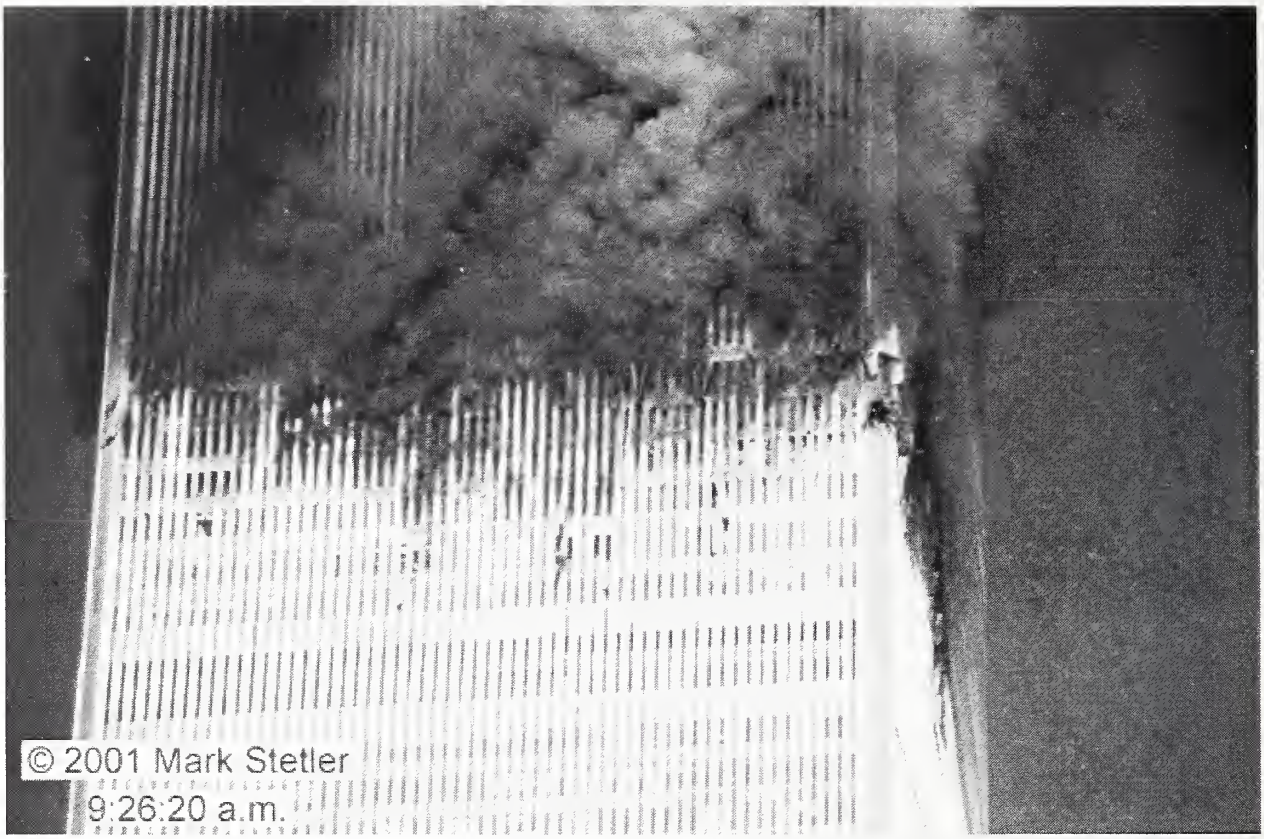
Comparison of Figure 9–27 with Figure 9–30 and Figure 9–31 provides an indication of how quickly the appearance of the east face could change during the smoke release events. In Figure 9–30 heavy smoke almost completely obscures the hanging object seen clearly less than a minute earlier through the 82nd floor windows. This smoke had been pushed out of open windows on the 79th through 82nd floors. In the blowup of the south side of the face in Figure 9–31, the hanging object is just visible at the tops of windows 82-329 through 82-333, as indicated by the arrow placed on the lower image in Figure 9–31. A small fire is visible at the top of window 82-229 above the object.

Figure 9-30. This photograph showing the east face of WTC 2 was taken at 9:26:20 a.m.

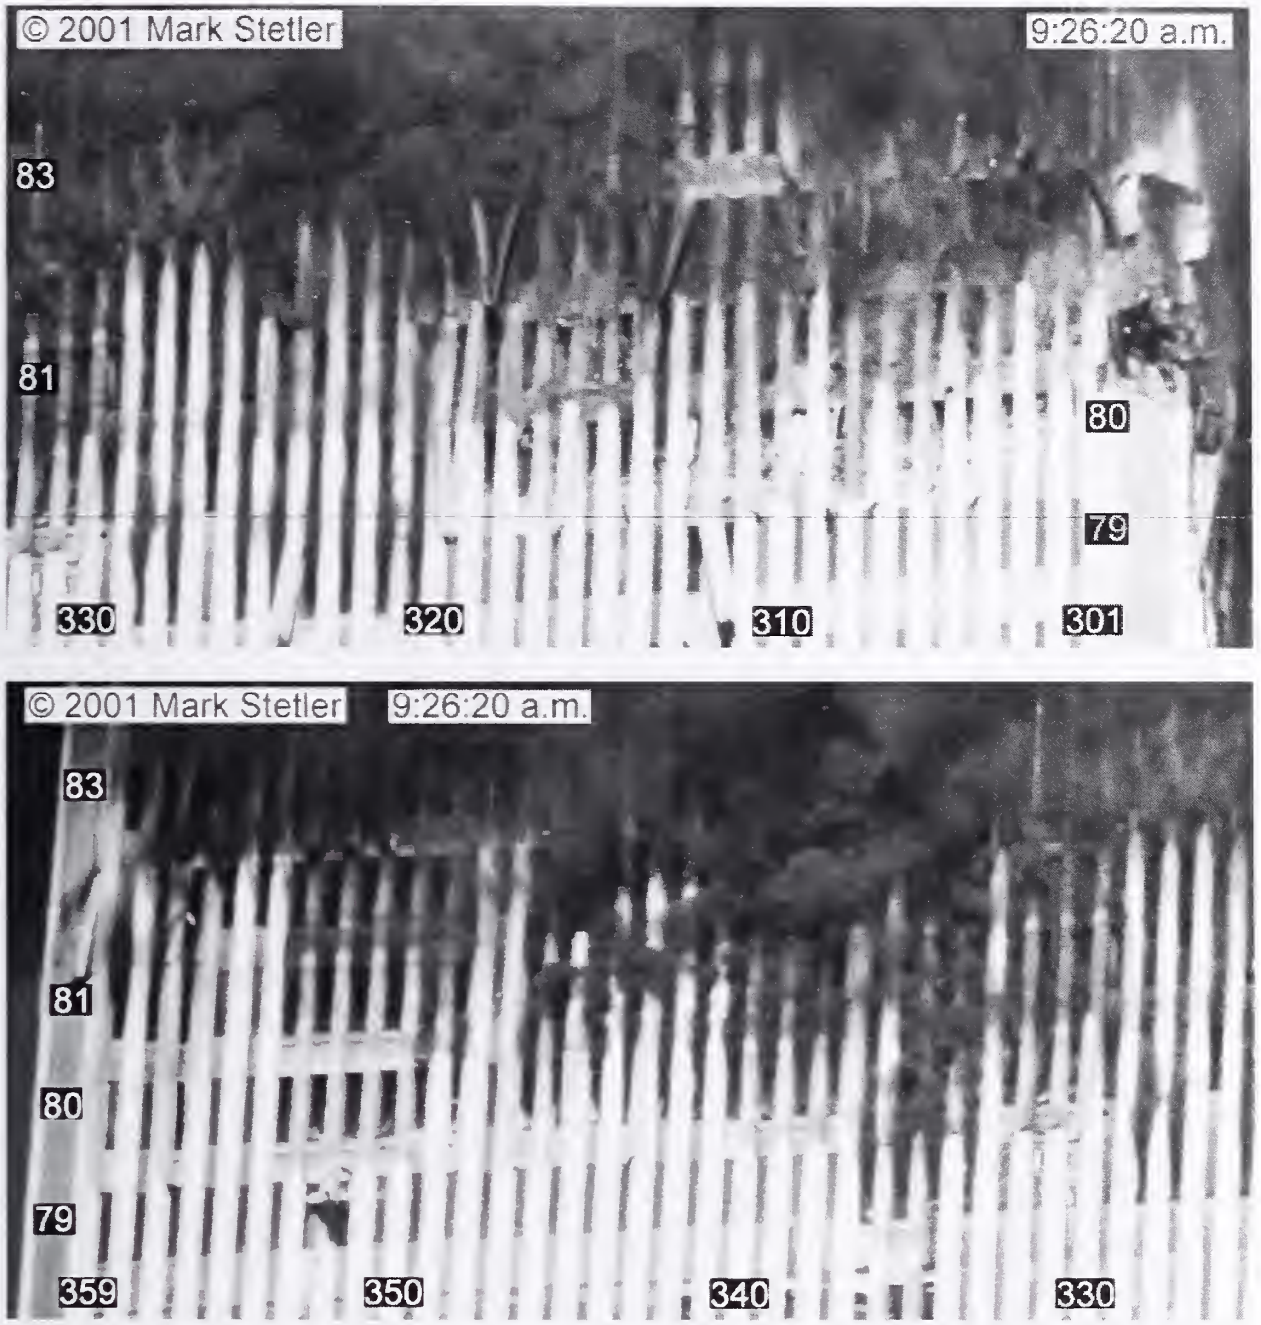
In this photograph (see lower image in Figure 9–31) the heaviest smoke flow on the 79th floor is from windows 79-333 to 79-336, but lighter smoke is also flowing from windows 79-320 to 79-325, 79-327, and 79-328. The glass is still in place for the intermediate windows where no smoke is observed, as well as on either side of windows 79-320 and 79-336. A long-distance video of the smoke release indicates that the relative density of smoke flowing from these windows varied rapidly with time and location and that heavy smoke was pushed from the other open windows during a portion of this release.

In Figure 9–31 smoke is also coming from open windows at the southern end of the east face on the 80th, 81st, and 82nd floors. Unlike on the 79th floor, flames as well as smoke are visible on the 80th floor in windows 80-333 to 80-340. Fire was present in this vicinity as early as 9:07:04 a.m. (see Figure 9–7). It has apparently grown slowly during the intervening 20 min. A small fire is also visible in window 81-335 on the 81st floor.

The heavy flames coming from windows 82-321 to 82-329 on the 82nd floor 33 s earlier in Figure 9–27 have retreated back into the windows. In Figure 9–31 extended flames are only visible in windows 82-326 and 82-327. The intense fire on the northern edge of the 83rd floor in Figure 9–27 has also died down. In particular, the flames that filled windows 83-310 to 82-312 earlier appear to have completely dissipated in Figure 9–31. The appearance of the fire burning on the northeast corner of the 81st floor has also changed. At the earlier time large flames were visible coming from the opening on the northeast corner. Thirty-three seconds later, the fire covered a much broader extent of the debris in the corner, while the flames in the northeast corner opening appeared to have died down. A long-distance video of this corner around this time shows that the intensity of the fire on the 81st floor was highly variable.

Figure 9-31. These two images show blowups of the north and south sides of the east face of WTC 2 taken from the photograph included in Figure 9–30, which was shot at 9:26:20 a.m. Column and floor numbers have been added. The arrow highlights a hanging object visible through open windows on the 82nd floor.

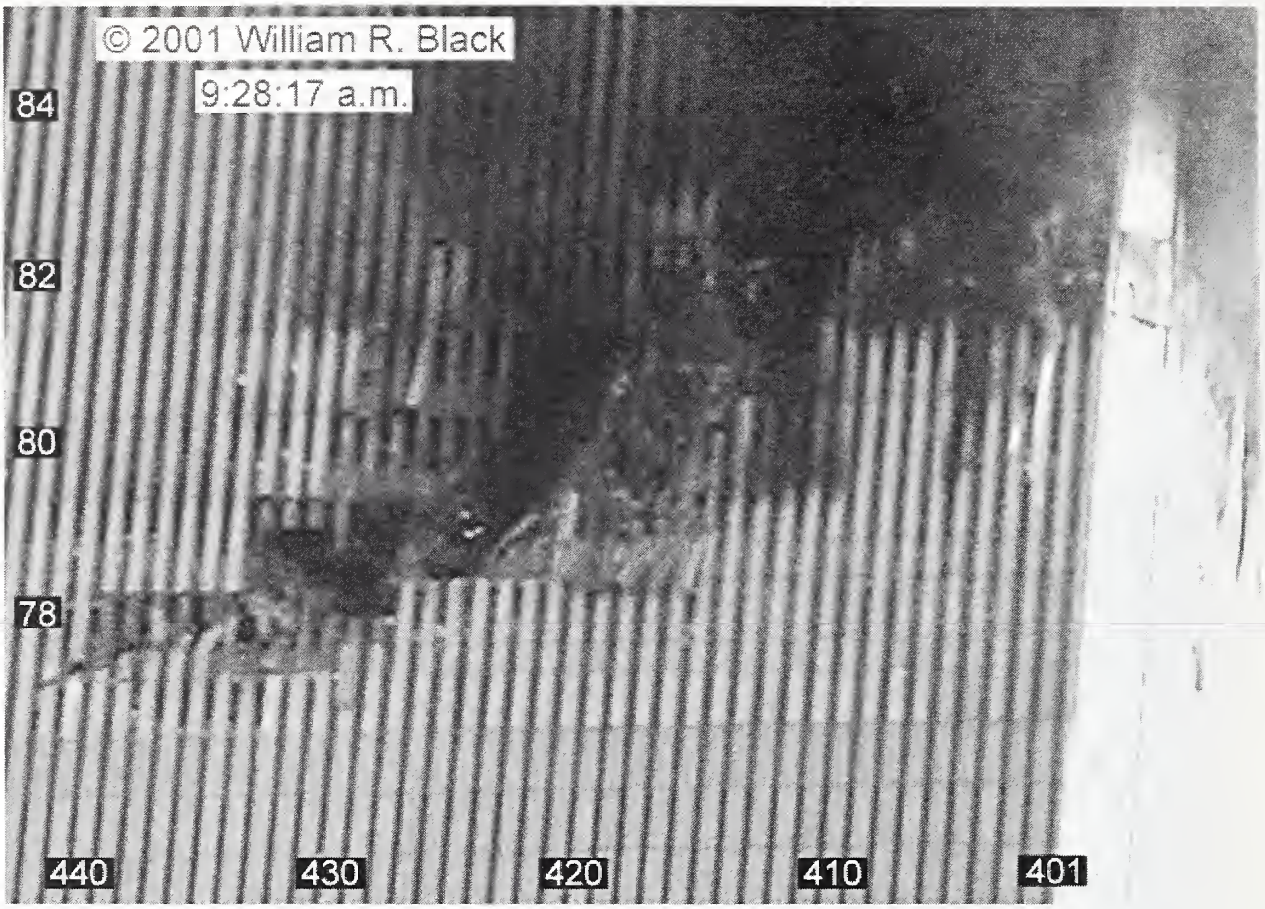
Figure 9-33. This cropped photograph showing the south face of WTC 2 was shot at 9:28:17 a.m. The image has been rotated, and the intensity levels have been adjusted. Column and floor numbers have been added.

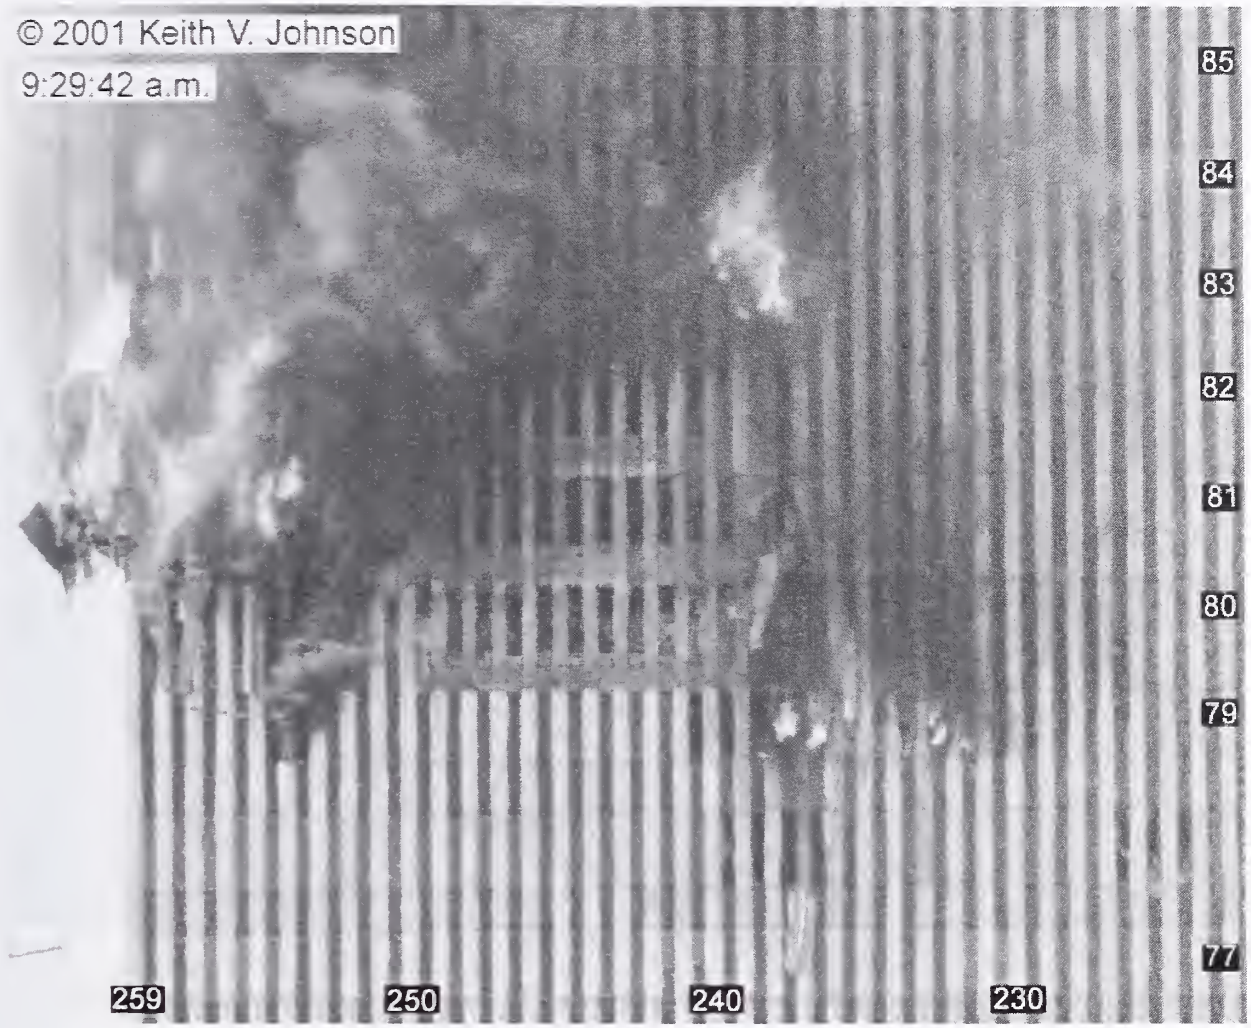
At first glance, it appears the new area of fire on the 83rd floor in Figure 9–35 is well separated from other flames on the floor. However, a dull red glow is barely visible in windows 83-240 to 83-245, suggesting there is a low intensity fire burning behind closed windows immediately above the cold spot. It seems this low intensity fire had spread further west, where it eventually broke out windows and then grew rapidly.

Comparison of Figure 9–35 with Figure 9–32, which was taken 2 min and 38 s earlier, shows how quickly the fire on the northern side of the 83rd floor grew and spread. At the earlier time there was no indication of a fire on the floor to the west of the small fires visible through windows 83-257 and 83-258. The appearance of fire at this location on the 83rd floor is the first visual evidence of significant fire spread on the north face of the tower. It took place almost 27 min after the aircraft struck the tower.

Figure 9-35. This cropped photograph shows the north face of WTC 2 at 9:29:42 a.m. The intensity levels have been adjusted, and column and floor numbers have been added

Elsewhere on the face, the appearance of the fires at 9:29:42 a.m. is much the same as at 9:27:04 a.m. The fires continued to burn on the debris piles at the eastern edges of the 81st and 82nd floors and closer to the center of the face on the 79th floor. The fires at the lower corners of the cold spot on the 80th floor are visible in both images. The hanging objects visible earlier in Figure 9–12 and Figure 9–16 are not immediately apparent in Figure 9–35. This is somewhat unexpected given the quality of the image.

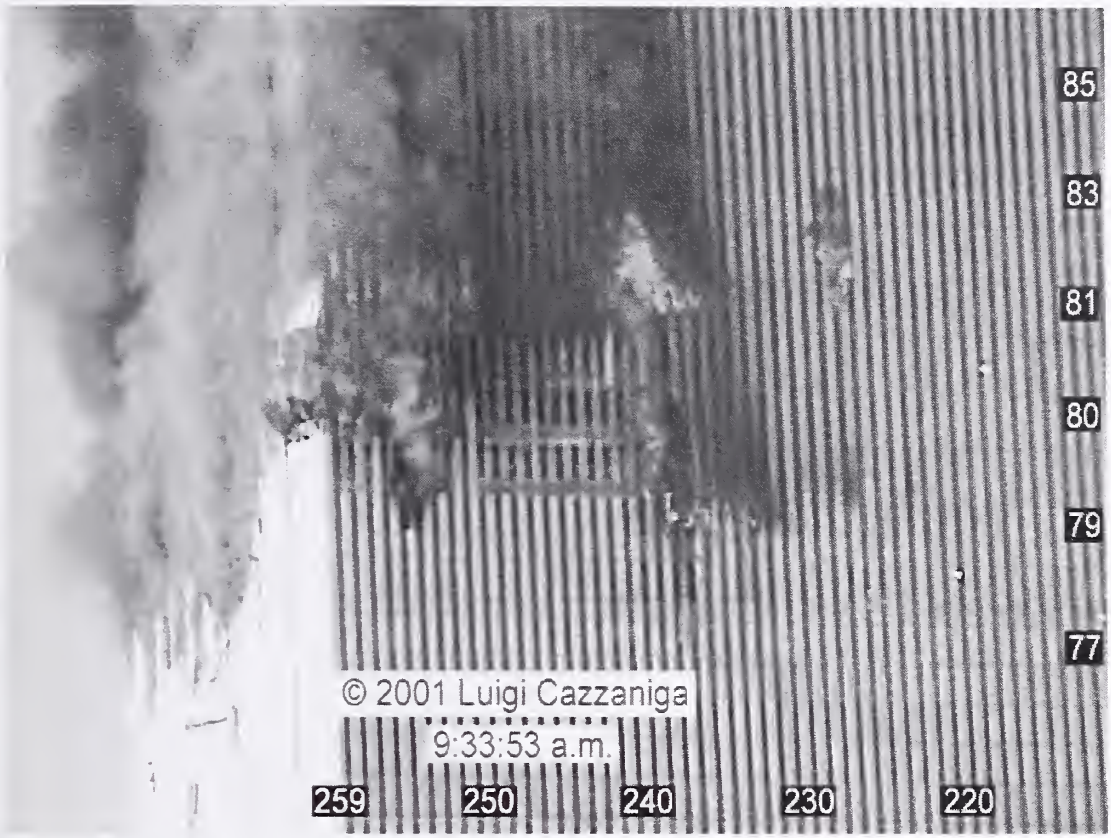
At 9:33:52 a.m. the fire burning on the 83rd floor of the north face seemed to jump several windows to the west when window 83-226 broke open, and a large flame exited. The resulting flare can be seen in Figure 9–37, which was recorded 0.9 s after the window opened. This large flame only lasted a few seconds, but after it died down heavy smoke and a shorter flame continued to come from the window.

Figure 9-37. This frame taken from a video shows the north face of WTC 2 at 9:33:53 a.m. The intensity levels of the image have been adjusted, and column and floor numbers have been added.

In Figure 9–37 small flames are visible in windows 83-240 to 83-244, which are located above the cold spot on the 83rd floor. This confirms that fires were present on this part of the floor. As an aside, since flames are not observed on the floor below, it also suggests that the 83rd floor slab is in place above the cold spot. The fires observed elsewhere on the face have similar distributions and intensities to those in Figure 9–32, Figure 9–35, and Figure 9–36.

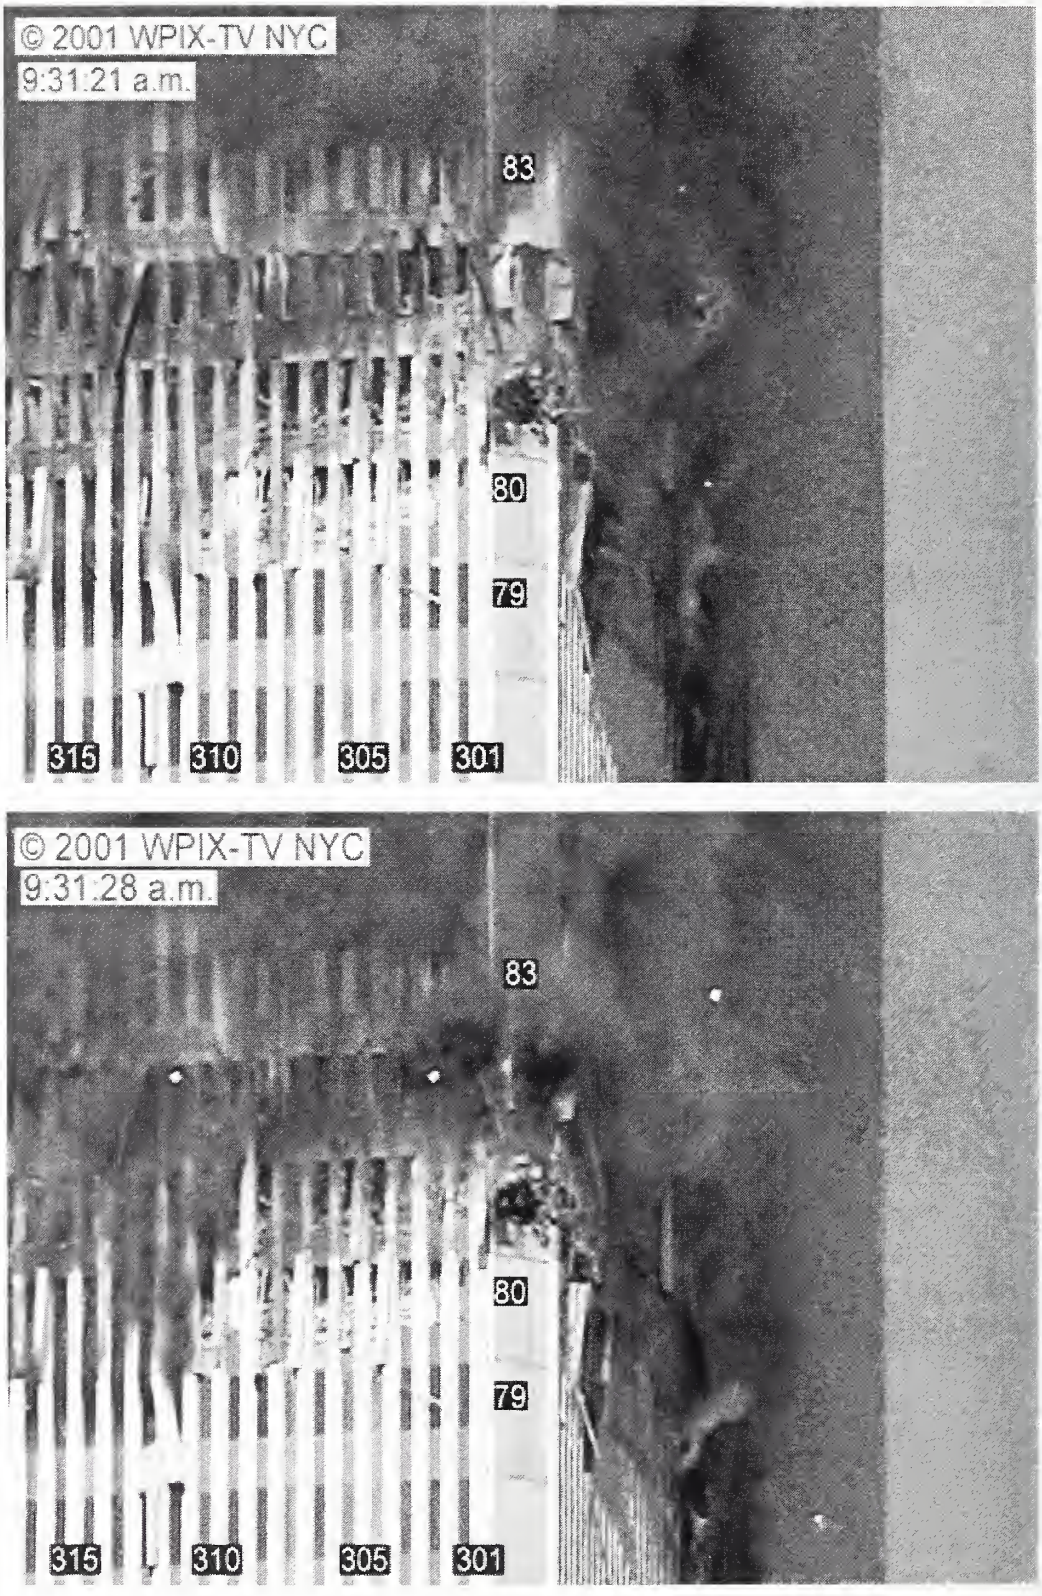
Two views of the northeast corner of WTC 2 are shown in Figure 9–38. The two images were captured from a video recording at 9:31:21 a.m. and 9:31:28 a.m. They were chosen to illustrate the appearance of the smoke puffs that had been observed periodically on the east face of WTC 2 for nearly twenty minutes. In the earlier image shown at the top of Figure 9–38, the visible portion of the east face is relatively clear of smoke. The only flame visible in windows on the east face at this time is the relatively small fire on the 81st floor in window 81-302, even though a fire continues to burn in the opening at the northeast corner of the 81st floor. Otherwise, the fires that were previously observed on this part of the east face seem to have died down. A video shot from a longer distance shows that shortly after the upper frame was recorded a smoke release occurred from multiple windows over multiple floors on the east face. This particular release was not as intense, i.e., less smoke was released, as others that were observed around this time.

Figure 9-38. Two frames captured from a video at 9:31:21 a.m. and 9:31:28 a.m. show the northeast corner of WTC 2. The intensity levels of the images have been adjusted, and column and floor numbers have been added.

The effects of the smoke release are evident in the lower image shown in Figure 9–38. Smoke has been pushed out of open windows on the 79th floor, i.e., windows 79-311 to 79-316, and can be seen rising above these windows. Comparison of the frames shows that the appearance of the smoke and fire in the vicinity of the burning corner on the 81st floor has also changed. Not only has smoke been pushed out of windows 81-301 and 81-302 and the opening on the northeast corner, but the fire intensity has also increased in the immediate area. Flames have been pushed out of windows 81-301 and 81-302. In the video it is clear that smoke was also pushed from windows on the 80th floor on the north side of the tower. In the lower image, this smoke appears as a white stream that has been pushed away from the building. In a video shot from a longer distance it was observed that smoke also appeared from windows on the 80th floor located on the south side of the east face. These observations suggest that the smoke puffs could be associated with pressure variations that were extensive enough to affect multiple floors and faces of the tower simultaneously. It should be noted that while the pressure variations that create the puffs may be the result of structural changes within the tower, the resulting pressure increases are likely to be much too small to have any impact on the structure.
